# Manhole Inspection Summary

Manhole # S55I\_\_015MH

Insp Date: **5/28/08 2:26 PM**

**Location** Address: **534 s conkling st**

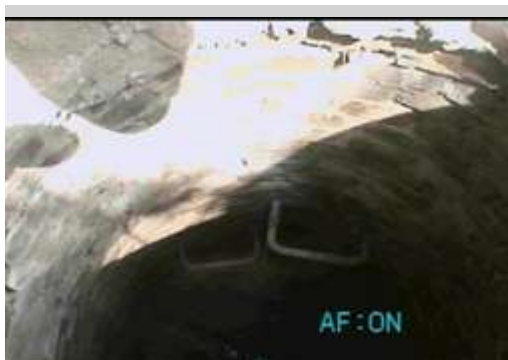
Defect 5

Count: **8** Missing: **2** ☒ **Corroded**

steps

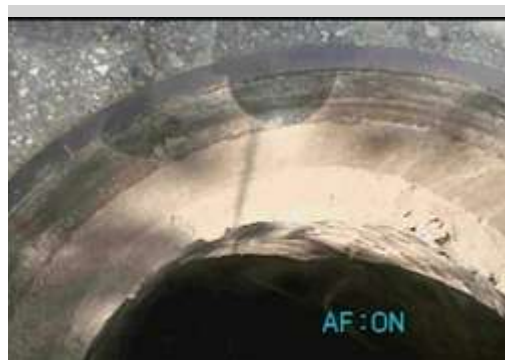
Defect 4

Offset: **2** (in.)

offset

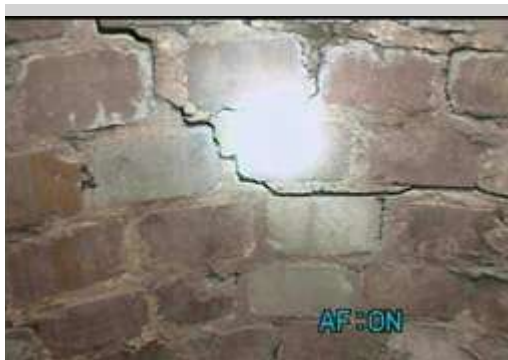
Defect 3

Condition: ☐ Sound ☒ **Cracked** ☐ Root Intrusion ☐ Loose Brick ☐ Deteriorated

barrel

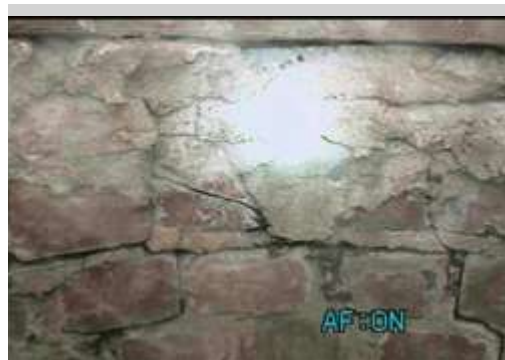
Defect 2

Condition: ☐ Sound ☒ **Cracked** ☐ Root Intrusion ☐ Loose Brick ☐ Deteriorated

corbel
